**Flood Control Project Maintenance
Levee Inspections**

Spring 2012 Levee Inspection Results

Sacramento River West Side Levee District

Levee Inspection Report By Mile - Spring 2012

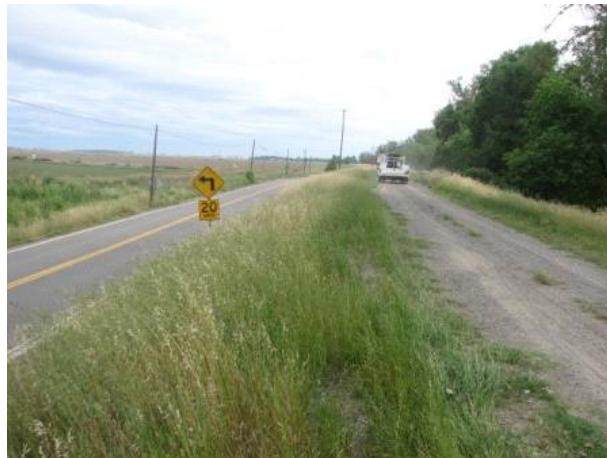
Levee Mile Report Line	4
Start Levee Mile	0.29
End Levee Mile	50.11
Location	Land Side
Category	Earthen Levee
Item	Vegetation

The stand of oats is greater than 12". Photo taken spring 2012.

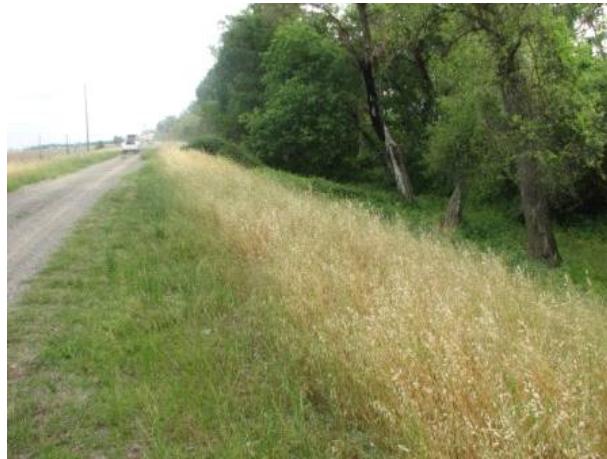
Levee Mile Report Line	5
Start Levee Mile	0.29
End Levee Mile	50.11
Location	Water Side
Category	Earthen Levee
Item	Vegetation

The oats are greater than 12". Photo taken spring 2012.

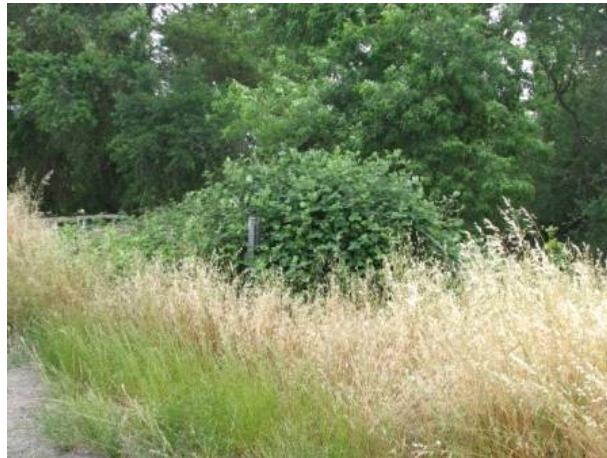
Levee Mile Report Line	6
Start Levee Mile	0.32
End Levee Mile	0.32
Location	Water Side
Category	Earthen Levee
Item	Vegetation

The berries block visibility. Photo taken spring 2012.

DWR ID: DWR_NA0016_01_s_2012_25			
6	0.32 0.32	Earthen Levee	Vegetation	WS M Ma	V2 : Remove the wild growth other than native grasses from the levee slopes.			38.803308 ° 38.803308 ° 27 -121.724190 ° -121.724190 ° Y			
								DWR ID: DWR_NA0016_01_s_2012_27			
7	0.98 0.98	Earthen Levee	Vegetation	LS C Ma	V2 : Remove the wild growth other than native grasses from the levee slopes.			38.812727 ° 38.812727 ° 6 -121.724496 ° -121.724496 °			
								DWR ID: DWR_NA0016_01_s_2012_6			
8	1.76 1.76	Earthen Levee	Encroachments	WS C Ma	FW : Firewood			38.823801 ° 38.823801 ° 1425 -121.724637 ° -121.724637 °			
								DWR ID: DWR_NA0016_01_s_2012_1425			
9	2.83 2.83	Earthen Levee	Vegetation	LS M En	V6 : Landscaping			38.837405 ° 38.837405 ° 4 -121.731717 ° -121.731717 ° Y			
								DWR ID: DWR_NA0016_01_s_2012_4			
10	3.59 3.97	Earthen Levee	Encroachments	LS A/W En	AD : Agricultural Ditch Inspector Comments: concrete lined			38.846767 ° 38.850758 ° 8 -121.729943 ° -121.725263 ° Y

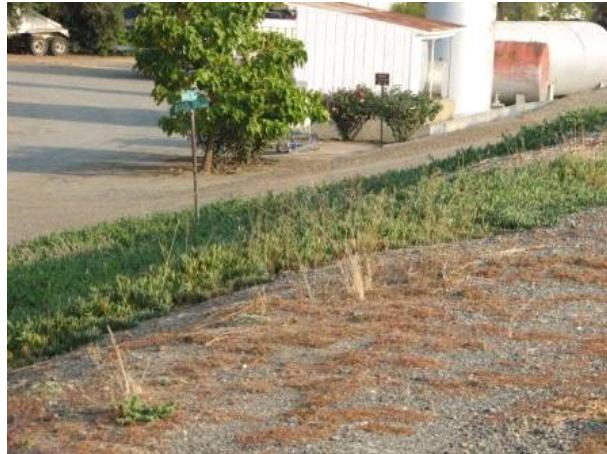
Levee Mile Report Line	9
Start Levee Mile	2.83
End Levee Mile	2.83
Location	Land Side
Category	Earthen Levee
Item	Vegetation
Landscape at River Garden Farms with irrigation.	
<i>johngw_s_20120313_181.jpg</i>

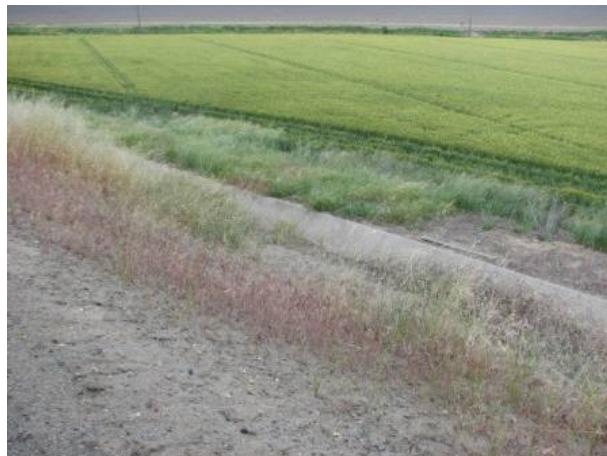
Levee Mile Report Line	10
Start Levee Mile	3.59
End Levee Mile	3.97
Location	Land Side
Category	Earthen Levee
Item	Encroachments
A concrete line ditch runs along the toe. Photo taken spring 2012.	
<i>johngw_s_20120507_794.jpg</i>

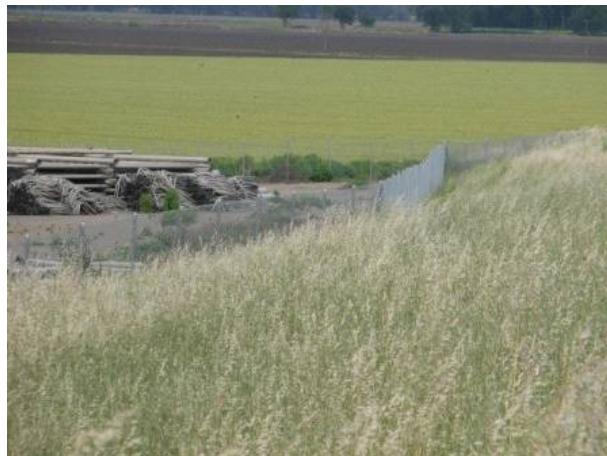
Levee Mile Report Line	12
Start Levee Mile	4.85
End Levee Mile	4.85
Location	Land Side
Category	Earthen Levee
Item	Encroachments
The chain link fence runs along the toe but does not obstruct the view. Photo taken spring 2012.	
<i>johngw_s_20120507_795.jpg</i>

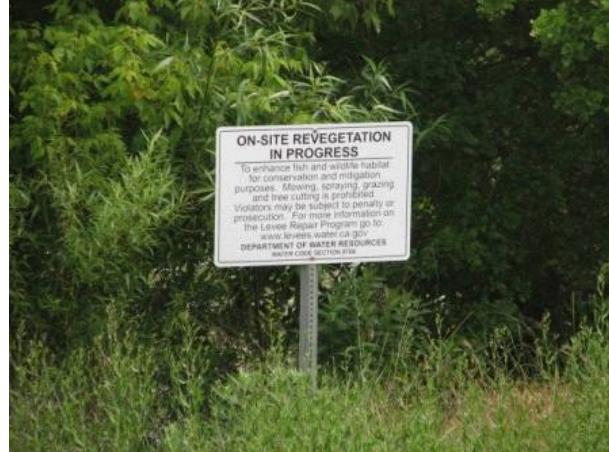
Revegetation site. Photo taken spring 2012.

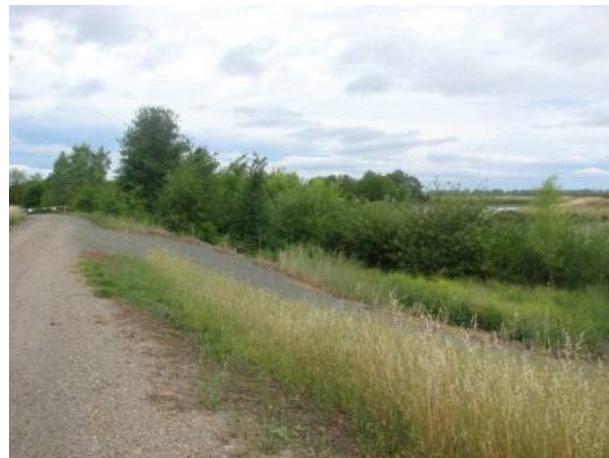
Levee Mile Report Line	13
Start Levee Mile	9.78
End Levee Mile	9.90
Location	Water Side
Category	Earthen Levee
Item	Vegetation

The revegetation site along the berm.

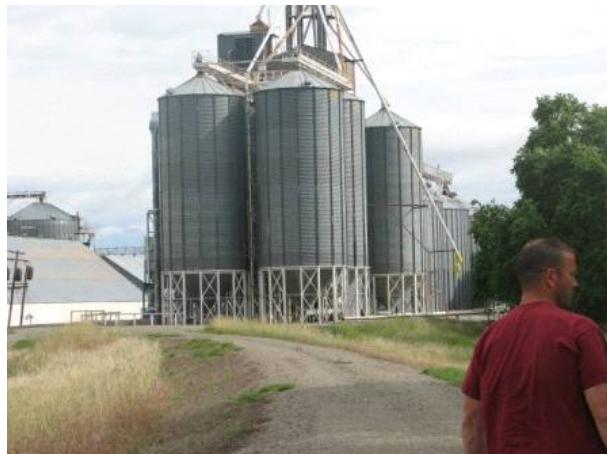
The rice silos are on top of the levee crown.
Photo taken spring 2012.

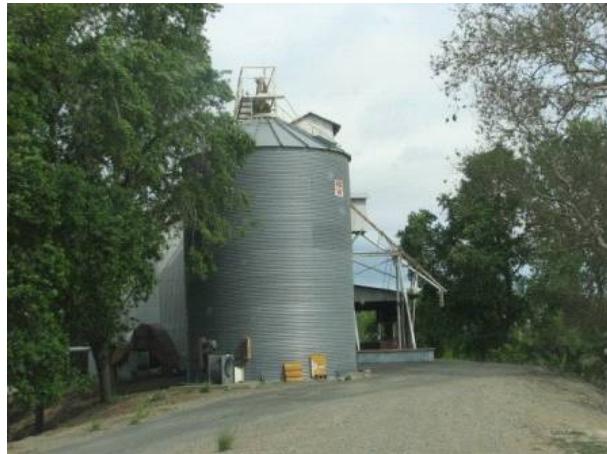
Another rice mill on the crown. Photo taken spring 2012.

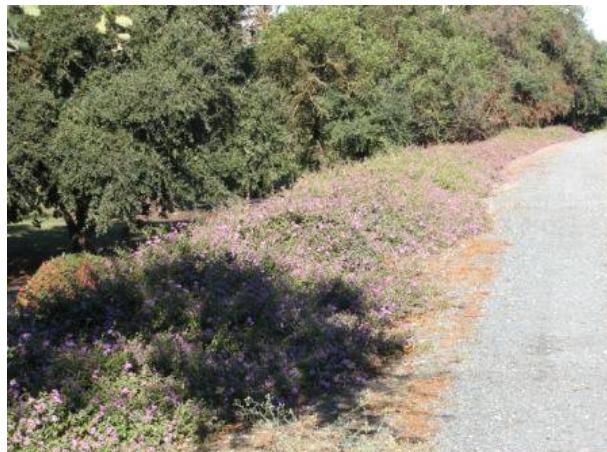
Groundcover and trees with irrigation are planted on the levee slope. Fall 2011.

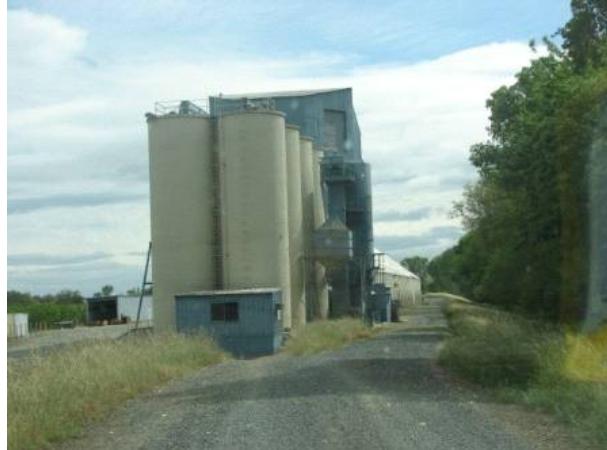
Another rice mill on the crown. Photo taken spring 2012.

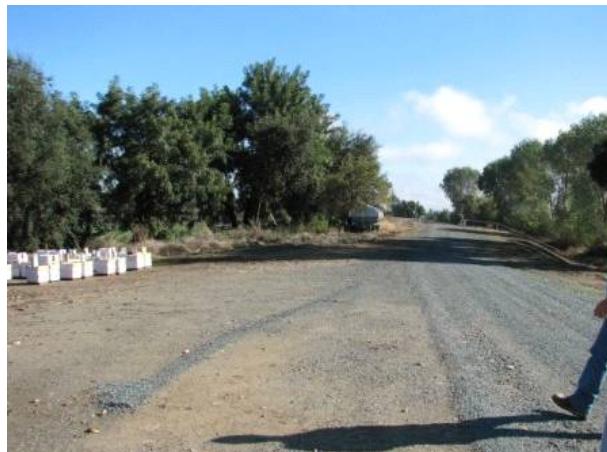
Levee Mile Report Line	24
Start Levee Mile	19.35
End Levee Mile	19.35
Location	Land Side
Category	Earthen Levee
Item	Encroachments

There is equipment on the levee crown and shoulder in the trees. Fall 2011.

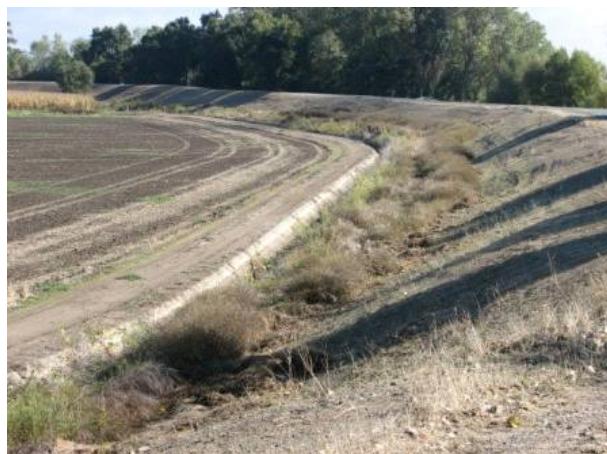
Levee Mile Report Line	25
Start Levee Mile	19.36
End Levee Mile	20.13
Location	Land Side
Category	Earthen Levee
Item	Encroachments

The concrete lined agricultural ditch runs along the toe. Fall 2011.

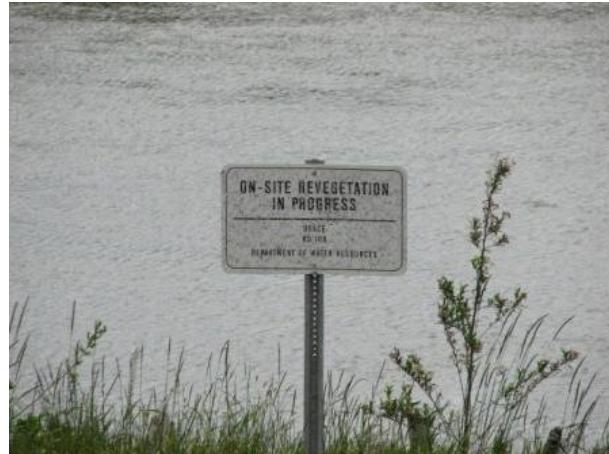
Revegetation site. Photo taken spring 2012.

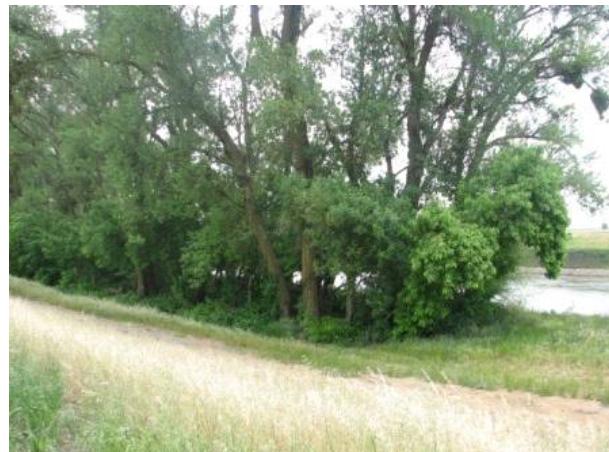
Levee Mile Report Line	27
Start Levee Mile	22.36
End Levee Mile	22.68
Location	Water Side
Category	Earthen Levee
Item	Vegetation

The revegetation site on the berm.

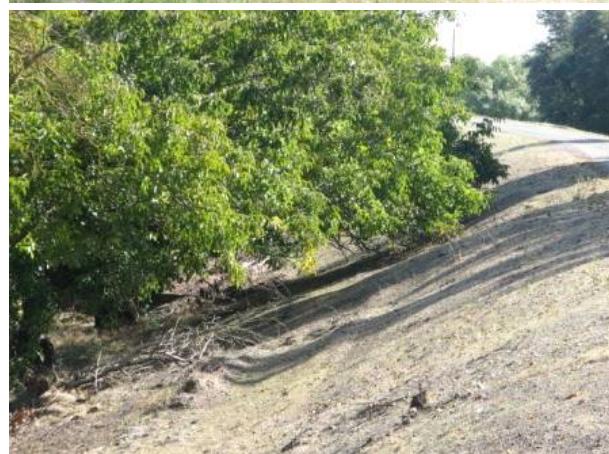
Levee Mile Report Line	28
Start Levee Mile	23.00
End Levee Mile	23.00
Location	Land Side
Category	Earthen Levee
Item	Trim / Thin Trees

The trees need to be trimmed up for visibility. Fall 2011

-121.816257 ° -121.810410 °	Y
										DWR ID: DWR_NA0016_01_s_2012_30	
28	23.00	23.00	Earthen Levee	Trim / Thin Trees	LS M Ma	T1 : Trim trees to at least five feet above ground level.				38.989785 ° 38.989785 °	28
										-121.804702 ° -121.804702 °	Y
										DWR ID: DWR_NA0016_01_s_2012_28

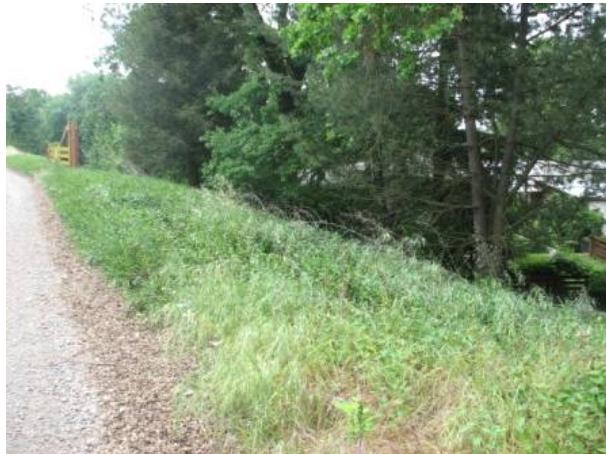
Levee Mile Report Line	30
Start Levee Mile	25.13
End Levee Mile	25.13
Location	Land Side
Category	Earthen Levee
Item	Vegetation

The tall grasses blend with the groundcover on the levee slope. Photo taken spring 2012.

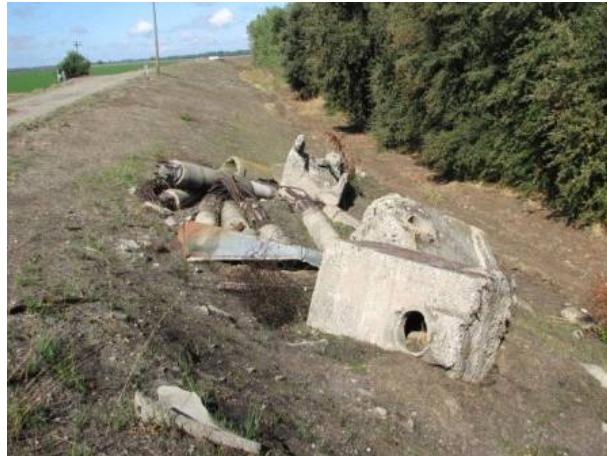
Levee Mile Report Line	33
Start Levee Mile	28.37
End Levee Mile	28.37
Location	Water Side
Category	Earthen Levee
Item	Encroachments
Concrete debris is on the waterside levee slope. Fall 2011.	
johngw_s_20120313_209.jpg

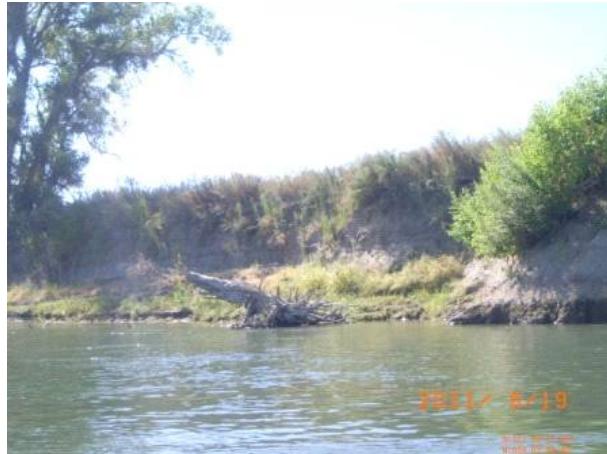
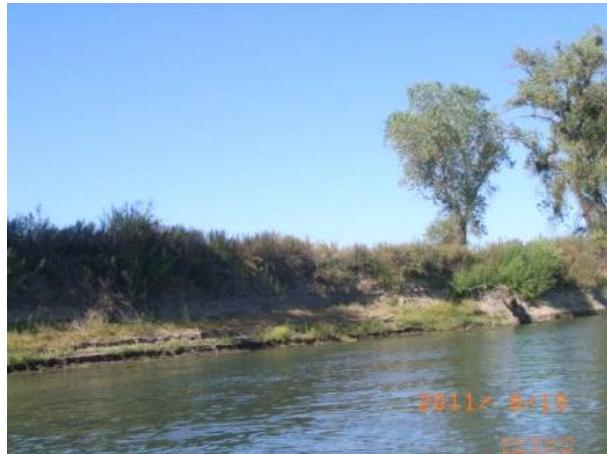
Levee Mile Report Line	35
Start Levee Mile	30.21
End Levee Mile	30.21
Location	Water Side
Category	Supplemental
Item	USACE Erosion Survey

35	30.21	30.21	Supplemental USACE Erosion Survey	WS M	Ma		Inspector Comments: 2002 - Upstream end has recent slope failure and exposure of tree roots. 2003 - Some new minor slope erosion with new snags on the bank. 2004 - Appears a little worse. 2005 - Scallop in bank at the upstream end looks worse. 2009 - Minimal new erosion. Berm width is still large, but one large event or one fallen tree and it could go fast. 2010 - New erosion, bank is nearly all vertical from slumping. Site looks bad. 2011: site starting to look bad. [2011 Site ID: SAC_122-3_R]	39.065886 °	39.066287 °	11	-121.842950 ° -121.843602 ° Y
											DWR ID: DWR_NA0016_01_s_2012_11
36	31.76	31.78	Supplemental USACE Erosion Survey	WS M	Ma		Inspector Comments: 1997 - Erosion into the levee section; old concrete rubble loss at toe; transition between the rock upstream and the cobble downstream. 2000 - Cohesive bench with concrete slabs on top; 25 ft deep scour hole on the downstream end. 2011: No observed change. [2011 Site ID: SAC_123-7_R]	39.066901 °	39.067004 °	12	-121.867322 ° -121.866913 ° Y

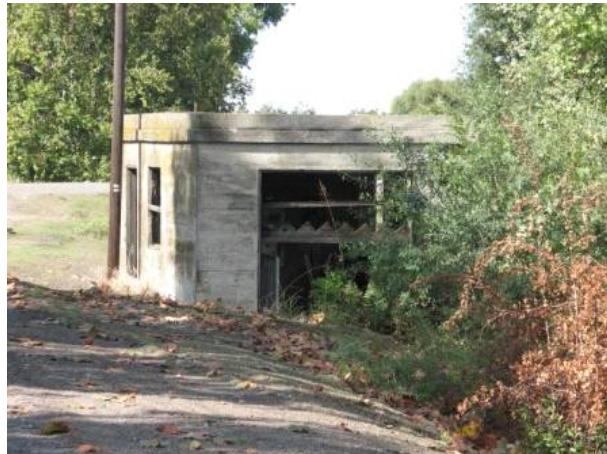
DWR ID: DWR_NA0016_01_s_2012_12
37	32.01	32.01	Earthen Levee	Encroachments	WS En	M	BU : Buildings Inspector Comments: Old concrete pumphouse on shoulder open needs to be sealed up.	39.066147 °	39.066147 °	60	-121.870425 ° -121.870425 ° Y
											DWR ID: DWR_NA0016_01_s_2012_60

Old concrete pump house on the waterside levee slope. Fall 2011.

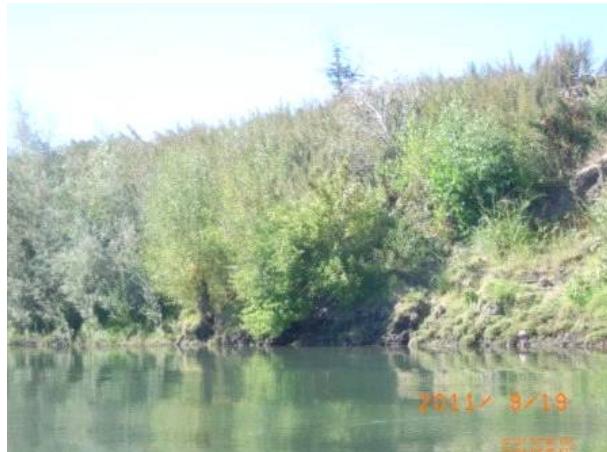
Levee Mile Report Line	42
Start Levee Mile	33.64
End Levee Mile	33.64
Location	Water Side
Category	Supplemental
Item	USACE Erosion Survey

-121.894200 °	-121.894200 °	
										DWR ID: DWR_NA0016_01_s_2012_44		
42	33.64	33.64	Supplemental USACE Erosion Survey	WS	M	Inspector Comments: 2008 - Slow erosion of the hard toe. 2010 - Cobble rubble is failing, erosion is into the toe of the levee, with vertical slumping. 2011: No observed change. [2011 Site ID: SAC_125-6_R]				39.078340 °	39.079351 °	13
										-121.894656 °	-121.895317 °	Y
										DWR ID: DWR_NA0016_01_s_2012_13		
43	35.47	35.47	Earthen Levee	Trim / Thin Trees	WS	M T2 : Thin trees to allow visibility of the ground and room to Ma flood fight.				39.096777 °	39.096777 °	1429
										-121.902873 °	-121.902873 °	Y
										DWR ID: DWR_NA0016_01_s_2012_1429		
44	35.62	35.62	Supplemental USACE Erosion Survey	WS	M	Inspector Comments: 1997 - Major scour off the downstream end of existing rock, creating a scour pocket where the levee starts diverging from the bankline. 2000 - Some minor erosion, 20 ft deep hole at downstream end. 2004 - Small amount of new erosion. 2010 - Bad transition off downstream end of rock revetment, some new erosion. 2011: No observed change. [2011 Site ID: SAC_127-9_R]				39.100084 °	39.100836 °	17

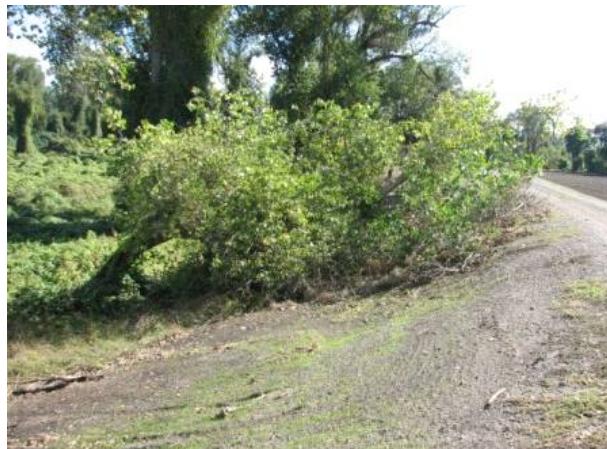
Levee Mile Report Line	43
Start Levee Mile	35.47
End Levee Mile	35.47
Location	Water Side
Category	Earthen Levee
Item	Trim / Thin Trees

The tree has fallen down on the levee slope. Fall 2011.

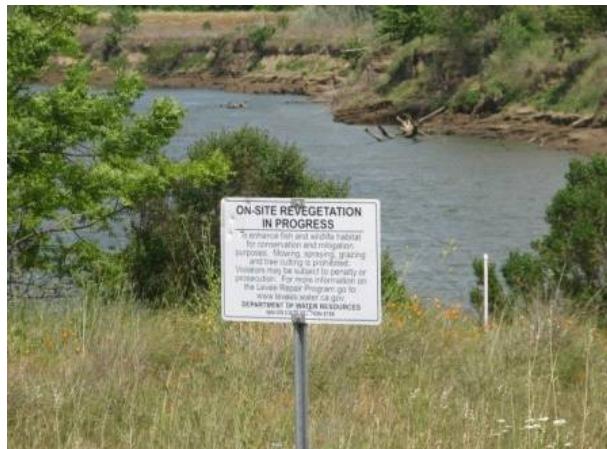
Levee Mile Report Line	45
Start Levee Mile	37.53
End Levee Mile	37.61
Location	Water Side
Category	Earthen Levee
Item	Vegetation

Revegetation site. Photo taken spring 2012.

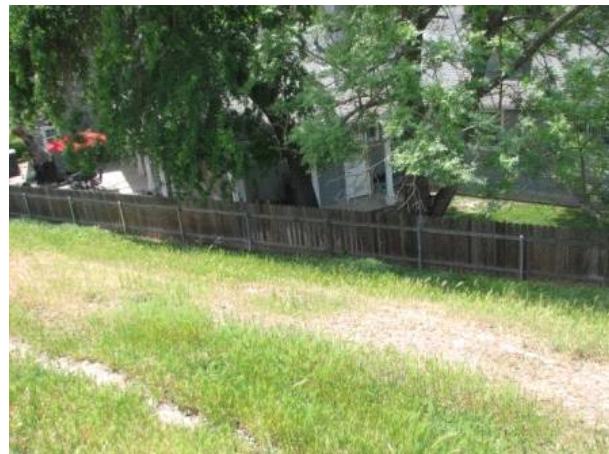
A solid fence along the toe of the levee. Photo taken spring 2012.

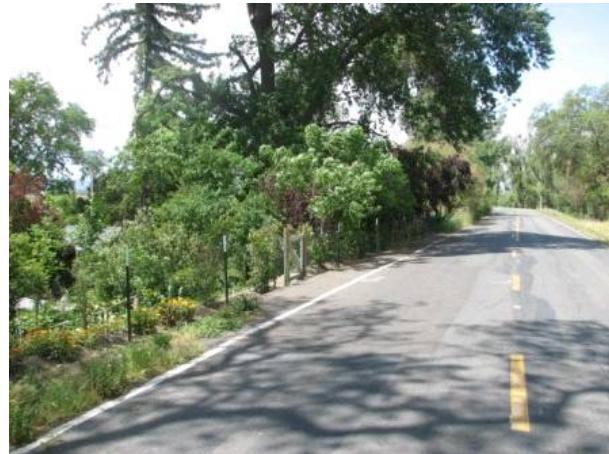
The front yard along the road and on the levee slope. Photo taken spring 2012.

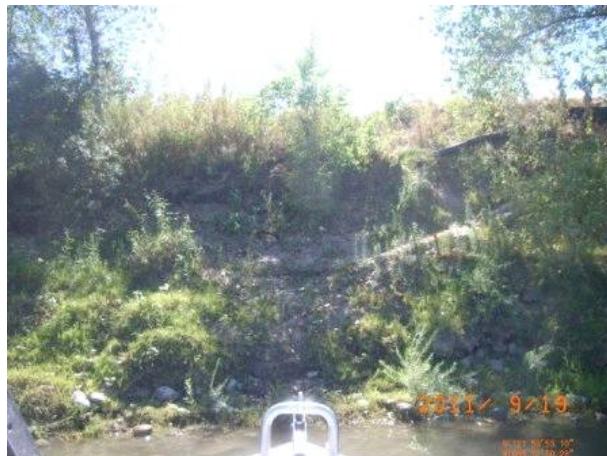
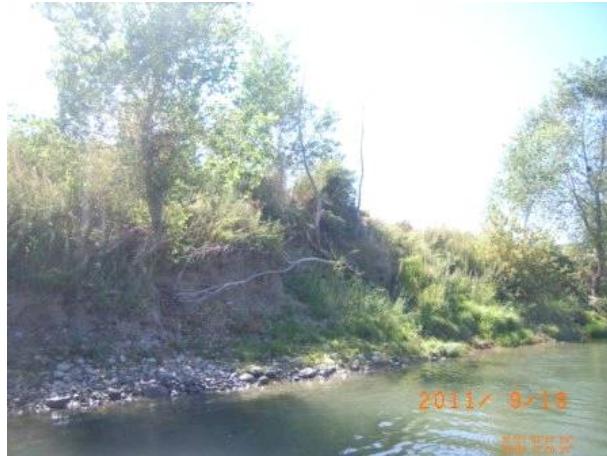
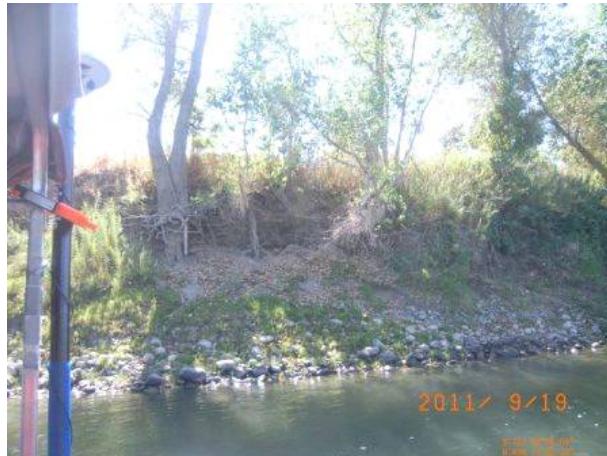
Levee Mile Report Line	58
Start Levee Mile	50.03
End Levee Mile	50.03
Location	Water Side
Category	Supplemental
Item	USACE Erosion Survey

-121.996354 °	-121.996354 °
										DWR ID: DWR_NA0016_01_s_2012_1436	
58	50.03	50.03	Supplemental Survey	USACE Erosion	WS Ma	M	Inspector Comments: 2011: multiple scallops, one tree pop out. old cobble site starting to unravel [2011 Site ID: SAC_143-5_R]			39.213608 °	39.213869 ° 24
										-121.997543 °	-121.999641 ° Y
										DWR ID: DWR_NA0016_01_s_2012_24	
59	50.11	50.11	Earthen Levee	Vegetation	LS En	M	V6 : Landscaping Inspector Comments: Agave plants at toe of levee			39.213613 °	39.213613 ° 58
										-121.998997 °	-121.998997 ° Y
										DWR ID: DWR_NA0016_01_s_2012_58

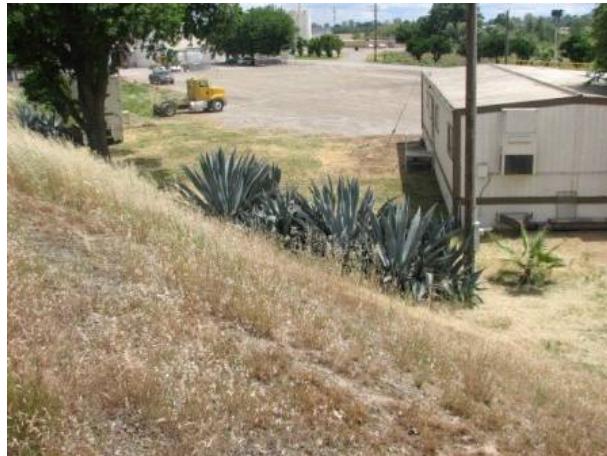
Levee Mile Report Line	59
Start Levee Mile	50.11
End Levee Mile	50.11
Location	Land Side
Category	Earthen Levee
Item	Vegetation

Cactus (Agave) planted along the toe. Photo taken spring 2012.
